UNDERWATER BRIDGE INSPECTION REPORT

STRUCTURE NO. 02519

CSAH NO. 22

RUM RIVER

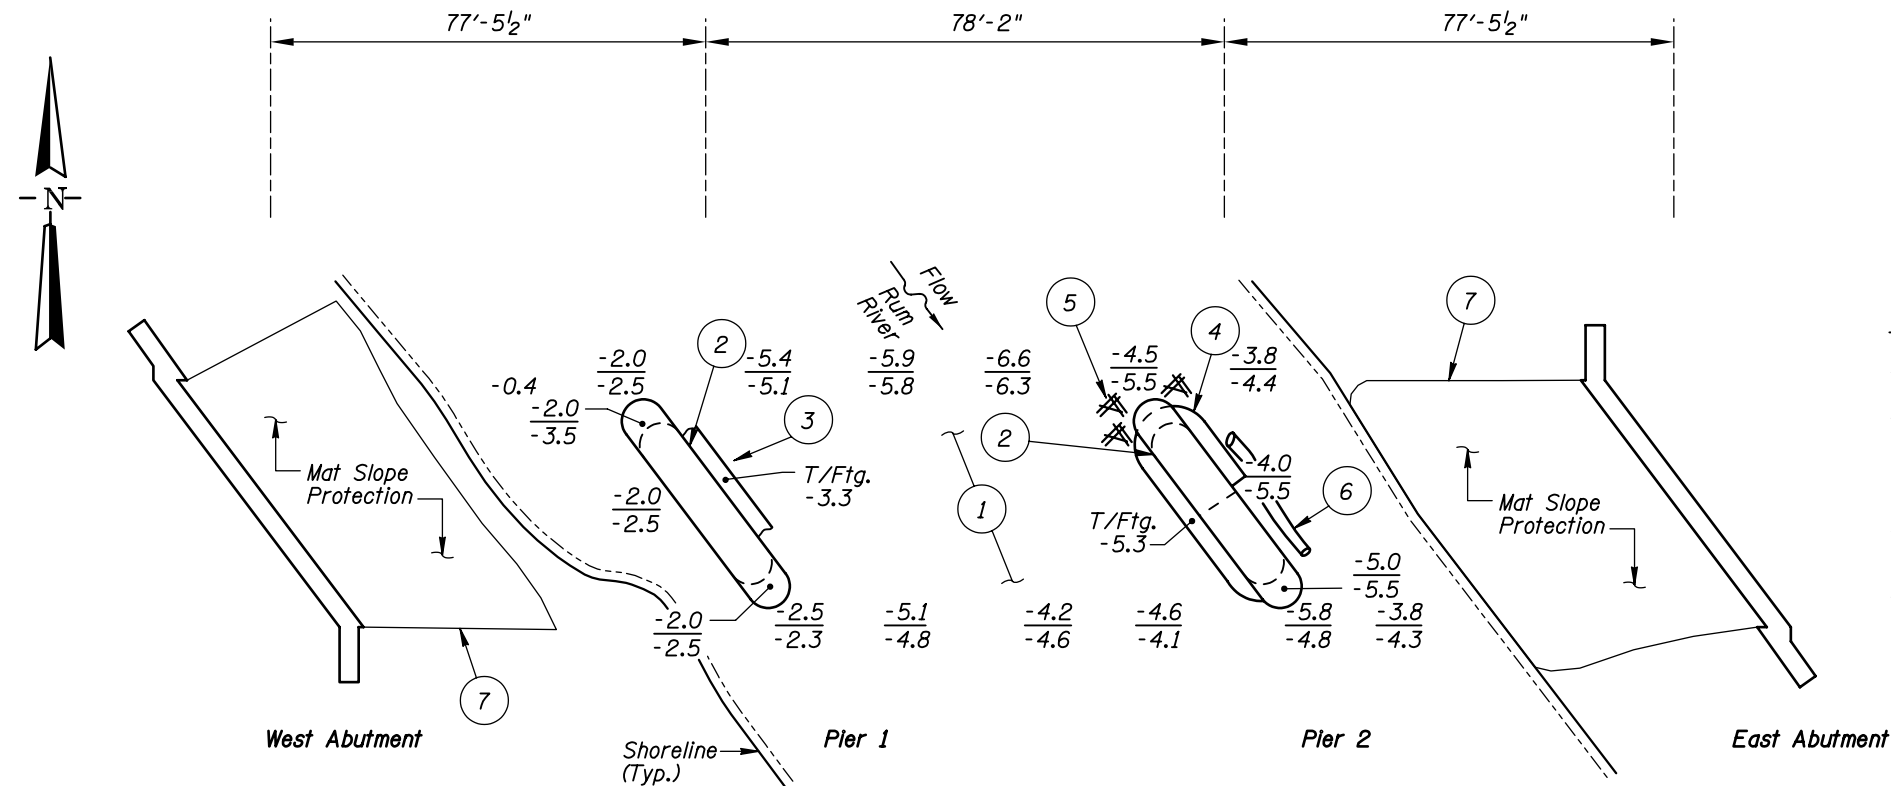
INSPECTION AND SOUNDING PLAN

- 1 The channel bottom material consisted of gravel with scattered 2 to 12 inch cobbles.
- 2 Light scaling was observed around both piers near the waterline with typical penetrations of 1/16 inch and maximum penetrations of 1/8 inch.
- 3 The top of the footing was exposed along the east face of Pier 1 with no vertical exposure observed.
- 4 The top of the footing was exposed along the entire west face, around the upstream nose, and down half of the east face with a maximum vertical exposure of 2 to 3 inches with timber formwork still present along the face.
- 5 A moderate accumulation of timber debris was observed at the upstream nose of Pier 2.
- 6 A 2-foot-diameter log was observed along the east face of Pier 2 on the channel bottom.
- 7 Minor erosion was observed around the perimeter of the mat shore protection.

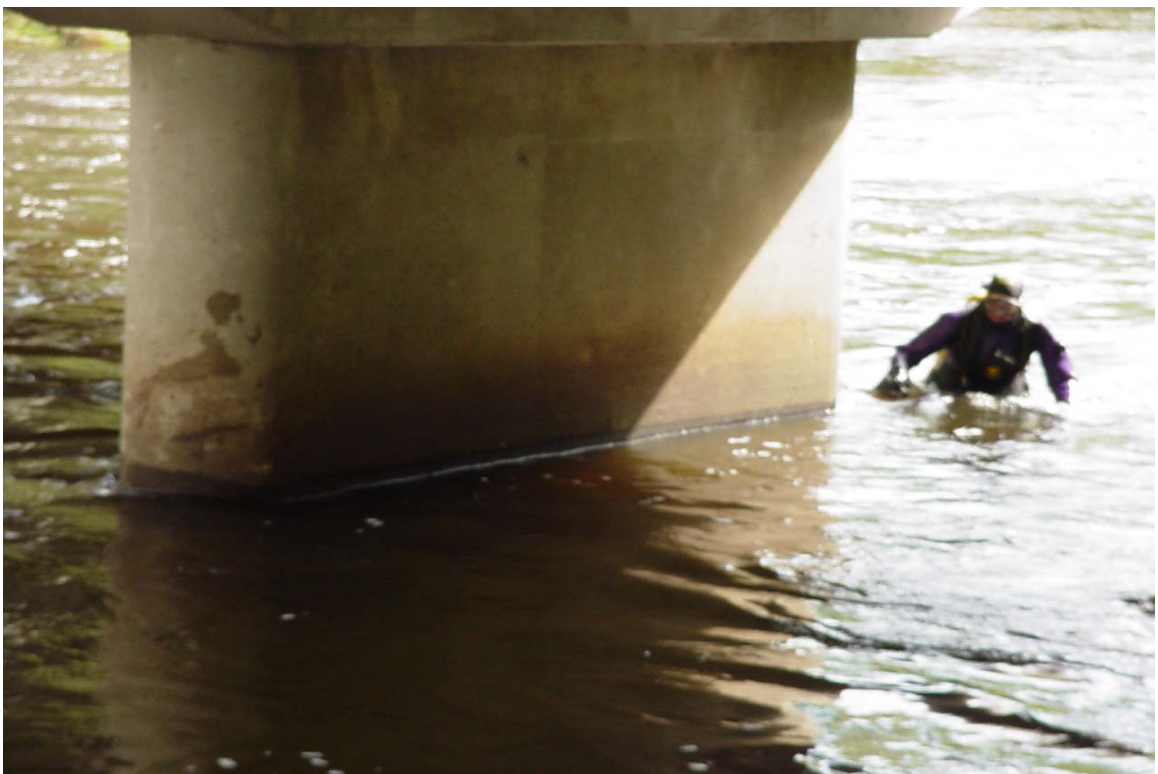
Photograph 2. View of Pier 1, Looking Southeast.

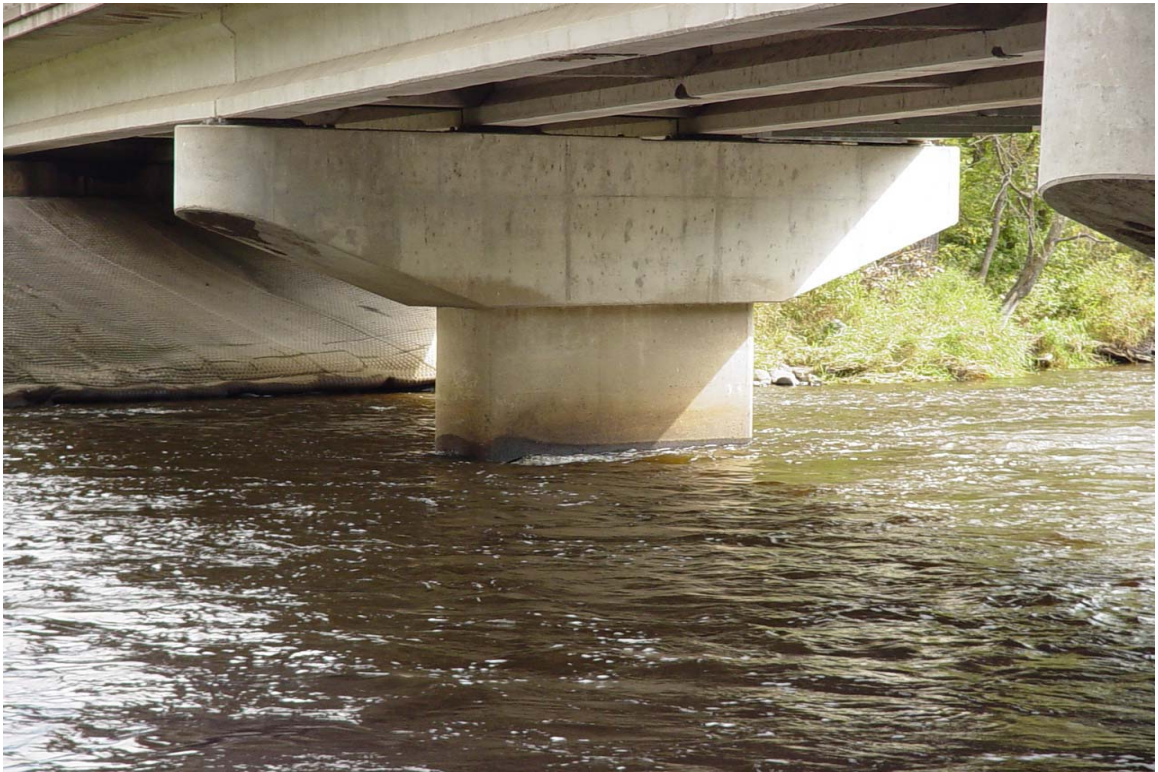
Photograph 3. View of Pier 2, Looking East.

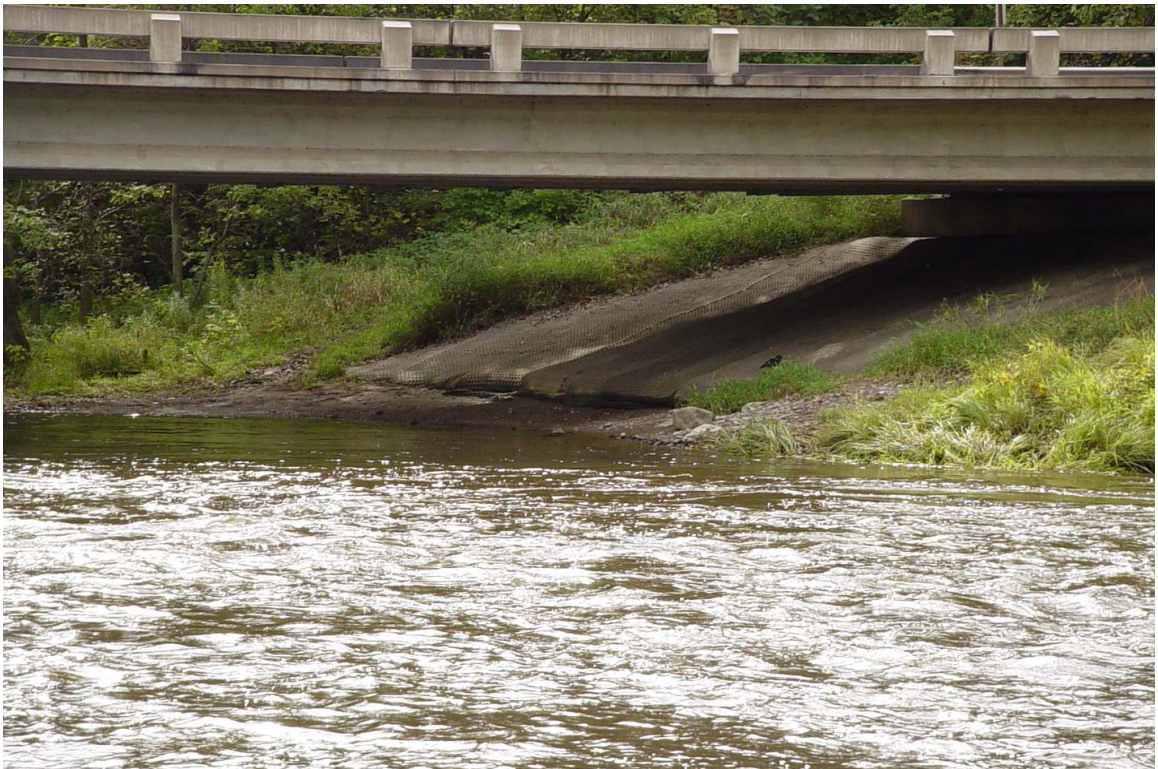
Photograph 4. View of West Abutment, Looking Southwest.
